GENESIS

MISHAP INVESTIGATION BOARD REPORT VOLUME I

**GENESIS MISHAP REPORT
VOLUME I**

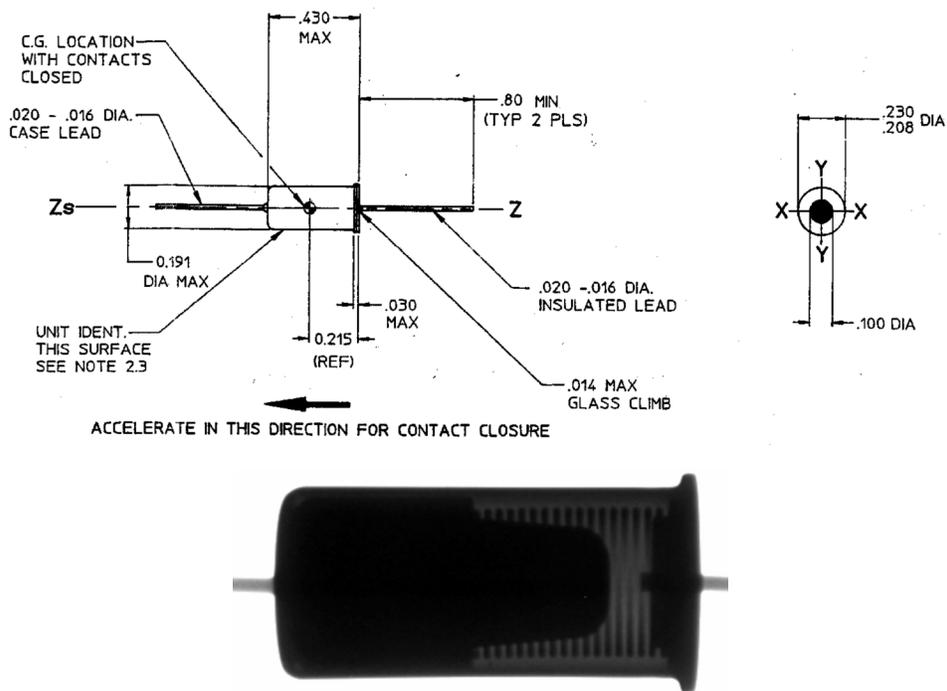
Figure 1.11.
Aerodyne 7200-6-000
acceleration switch
(G-switch sensor) drawing
and X-ray.

The G-switch sensor is an acceleration-sensitive sensor, which is somewhat smaller than the metal ferrule of a common wooden pencil (Fig. 1.11).

The acceleration direction required to close the switch is shown in Figure 1.11. An X-ray of the G-switch sensor shows how the spring mass and contact are oriented inside the cylinder (Fig. 1.11). The closure lip provides a good orientation reference between the photograph of the exterior and the X-ray of the interior of the G-switch sensor. When the G-switch sensor is mounted in the correct orientation, the internal plunger compresses against its spring as the g's are increased, making electrical contact. The g profile for the Genesis entry, shown in Figure 1.12, was close to the pre-launch prediction.

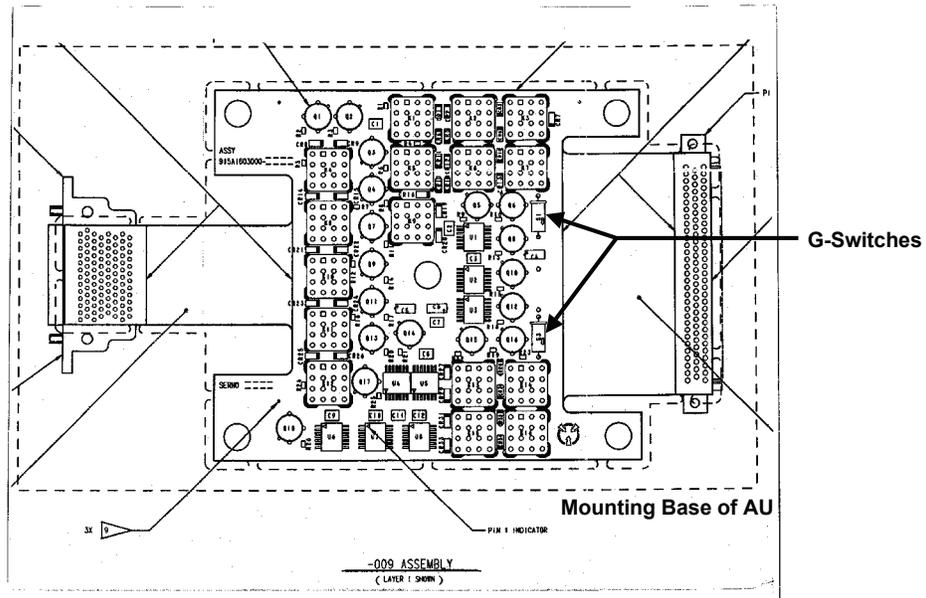
The Board determined the proximate (or direct) cause of the mishap to be that the

G-switch sensors were in an inverted orientation, per an erroneous design, and were unable to sense sample return capsule deceleration during atmospheric entry and initiate parachute deployments. Section 4.0 describes the proximate cause and lists other candidates that the Board investigated.

Figure 4.1.
Relay card
assembly drawing.

Figures 4.1 and 4.2 show an assembly drawing and close out photograph of a flight relay card with G-switch sensors, respectively.

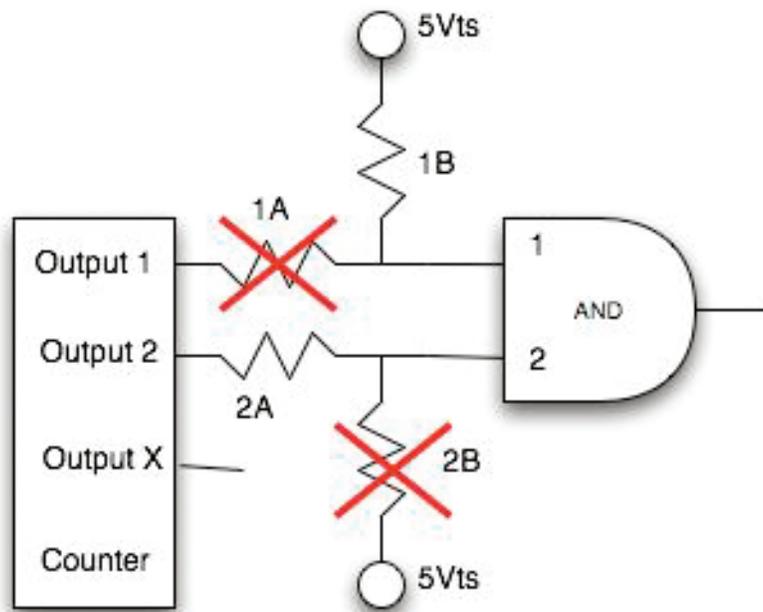
Figure 7.1.
Example of EST timing
circuit and timing jumper/
resistor placements.

The Avionics/Pyrotechnics/EEE Parts Subteam reviewed the base-lined drawings and subsequent changes, made with respect to the placement of the timing resistors and the respective signal timing expected from those resistor positions.

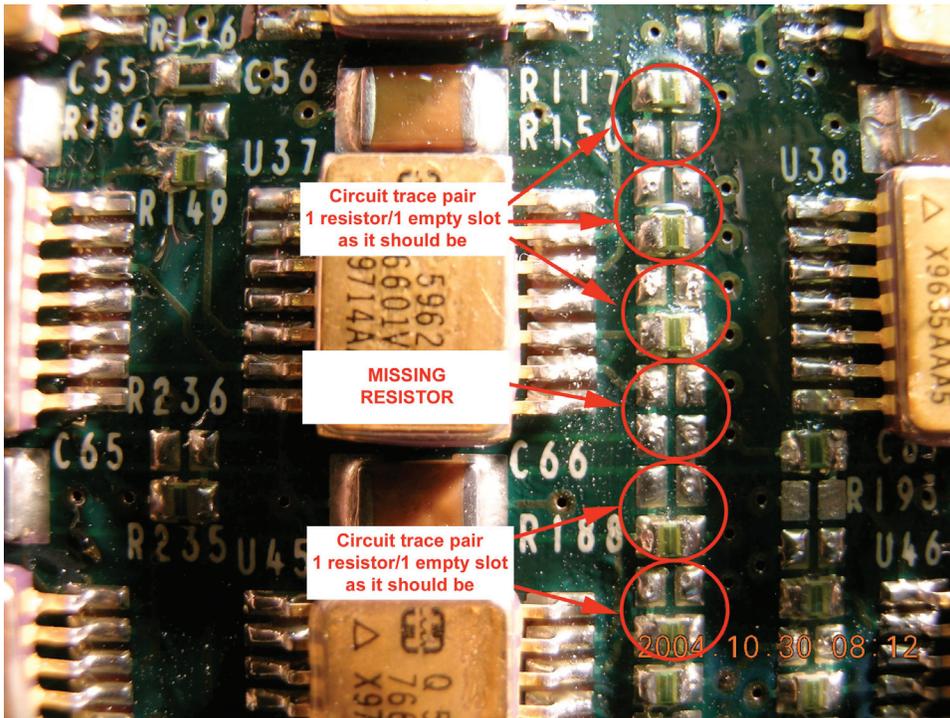
Figure 7.2
Example of resistor pairs and the intended location of the missing resistors.

What this floating input means for the timing circuit is that if the input happened to ‘float’ to a logic ‘1’ during the timing sequence, the circuit would have worked as expected. However, if the input ‘floated’ to a logic ‘0’, that particular timing circuit would have failed to send a ‘fire’ signal to its pyro. Since there was a redundant

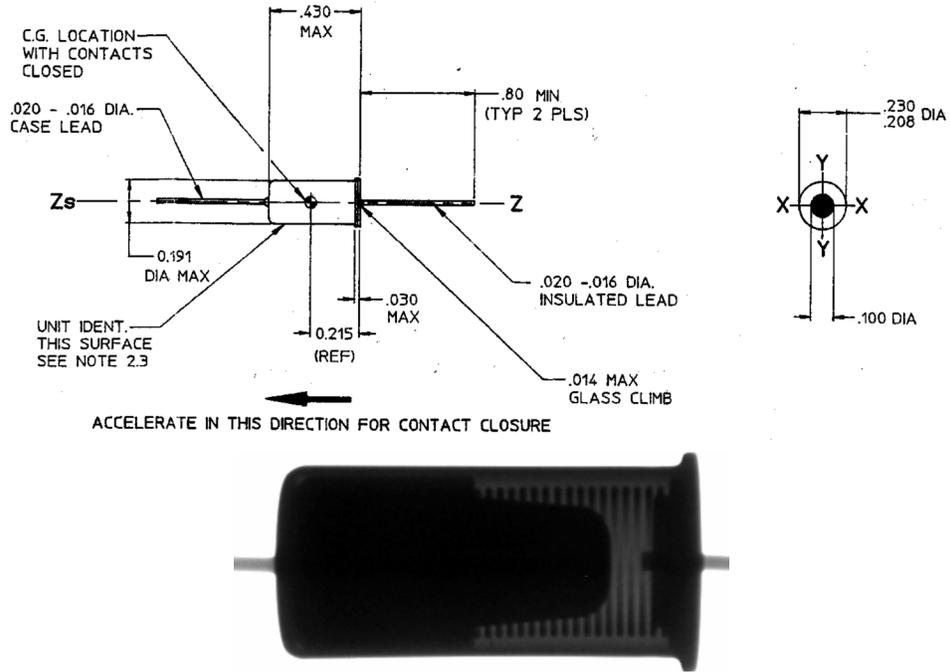
Figure B-14.
Aerodyne 7200-6-000
acceleration switch
(G-switch sensor) drawing
and X-ray.

deceleration dropped below 3 g's as the capsule slowed, the plunger would have been pushed away from the contact, breaking the circuit and causing the EST to start, leading to the successive deployments of the drogue and parafoil.
