Beagle-2 Aftermath: *Post-landing phase and lessons learned*

**3rd Interplanetary Probe Workshop, Anavyssos, Greece
27 Jun – 1 Jul 2005**

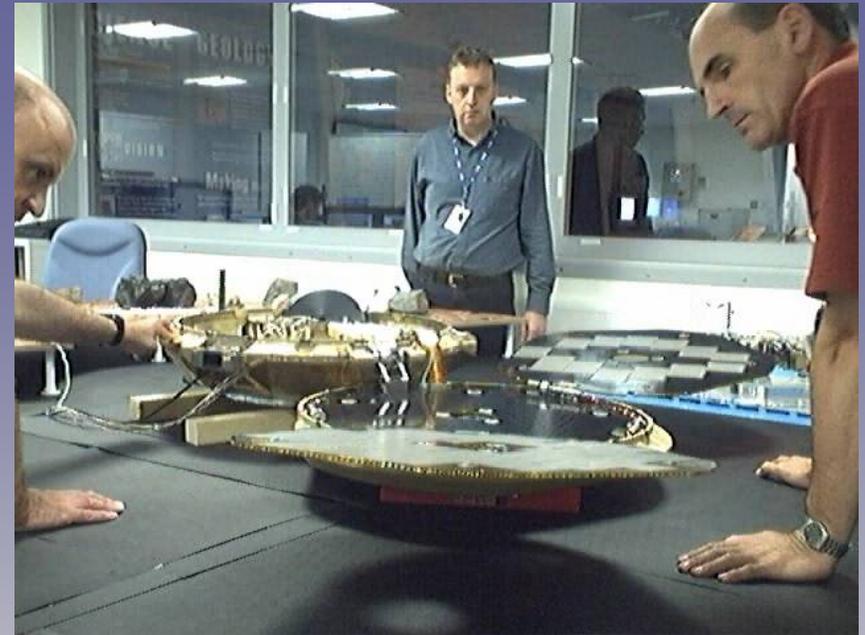
First Night

Phobos transit imaging ⇒ *localisation of landing site*

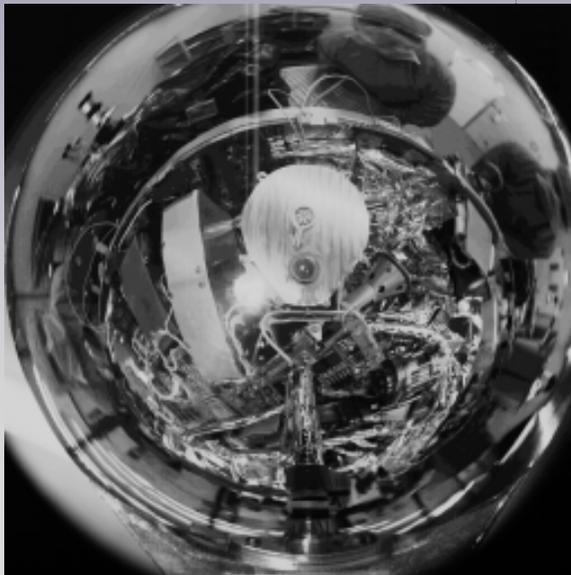
Sols 2-3

- start payload management (engineering HK from GAP)
- frangibolts fired on ARM and PAW
 ⇒ *removes thermal path to electronics*
- PLUTO (“mole”) launch lock released
- more imaging
- PTUVWD (!)

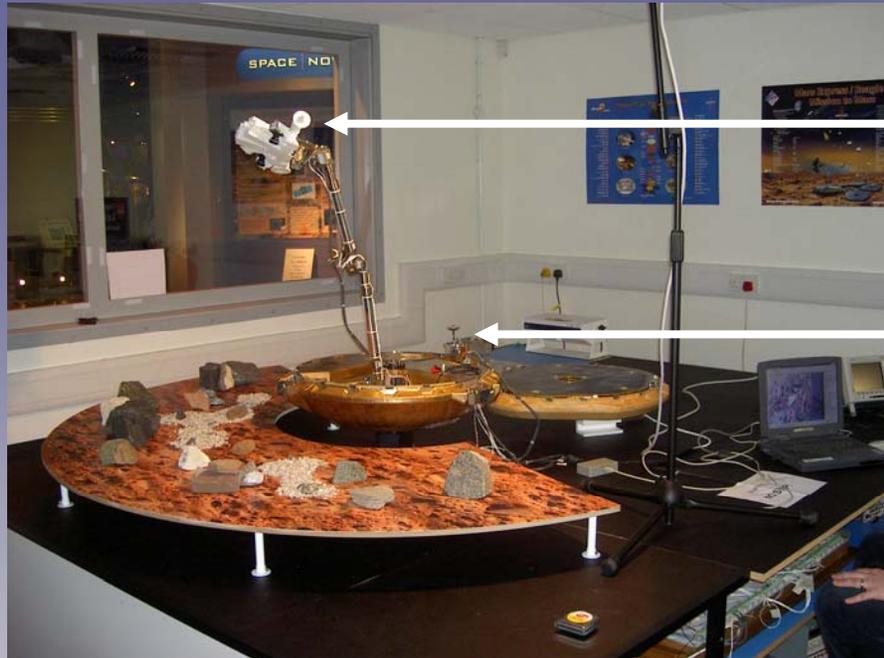
- Ground Test Model is a working replica of the Flight Model
- Majority of components are from Development Model, e.g.
 - Lander Base with dummy Solar Panels
 - Common Electronics, running PSW or LSW
 - ARM
 - Transceiver

- Third mass instrument PAW used to simulate weight under Martian gravity
- QM PAW with real instruments also available for testing

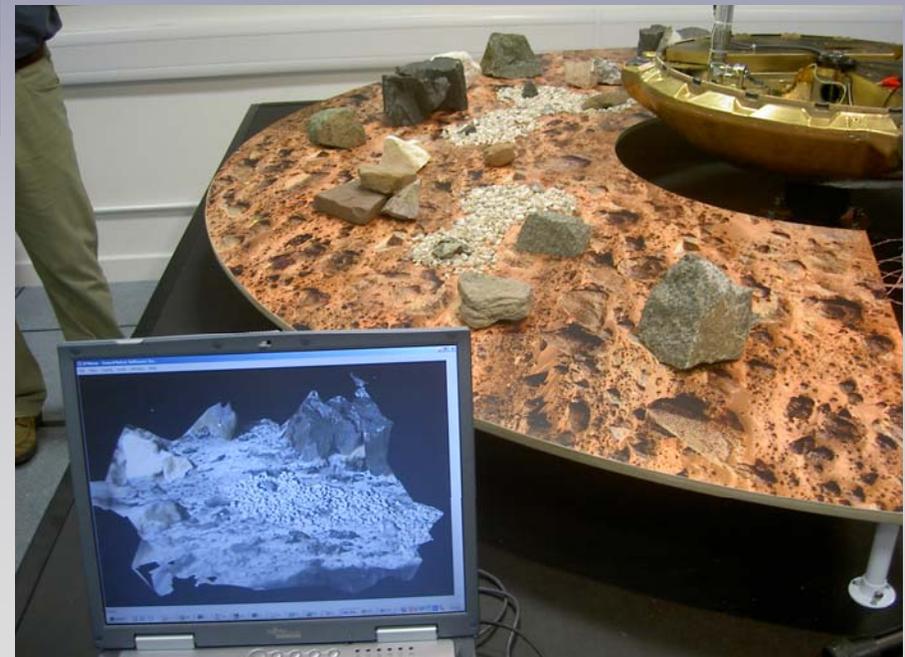
- Surface terrain can be recreated for use with GTM
- Digital Elevation Model (created here from mock terrain) used for ARM VR

- Complex manoeuvres – such as rock contact – can be planned with VR
- Additional information given by the system includes
 - Motor torques
 - Potentiometer values
 - Motor currents
 - Manoeuvre durations
