Mars Exploration Rover Heatshield Observation Campaign

Christine Szalai, Benjamin Thoma, Justin Maki, Wayne Lee
Jet Propulsion Laboratory

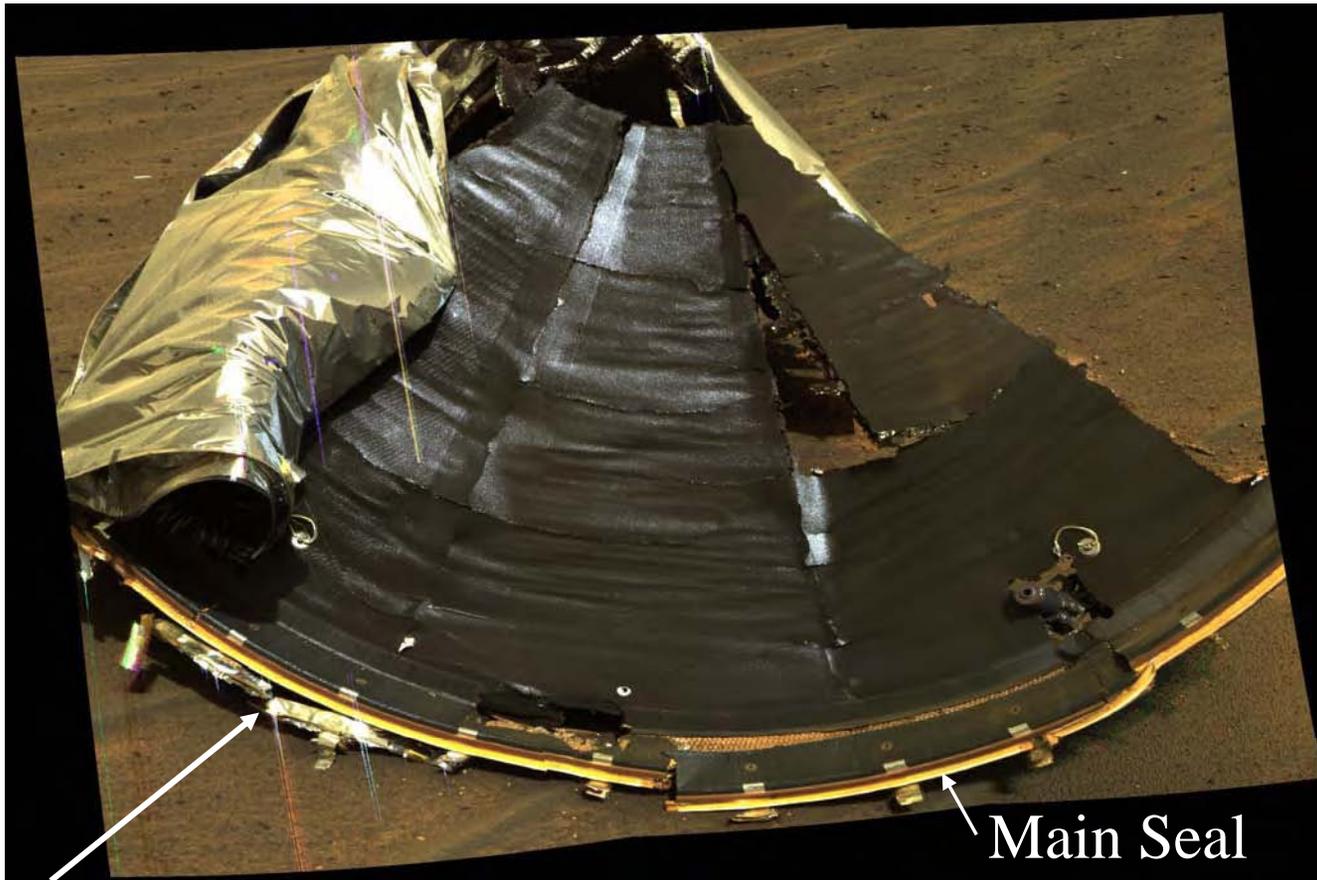
Main Seal and Structure Observations

Thermal Blanket tape strip remnant

Observation of tape strip remnant is being studied as a possible cause of unexpected angle of attack growth during entry

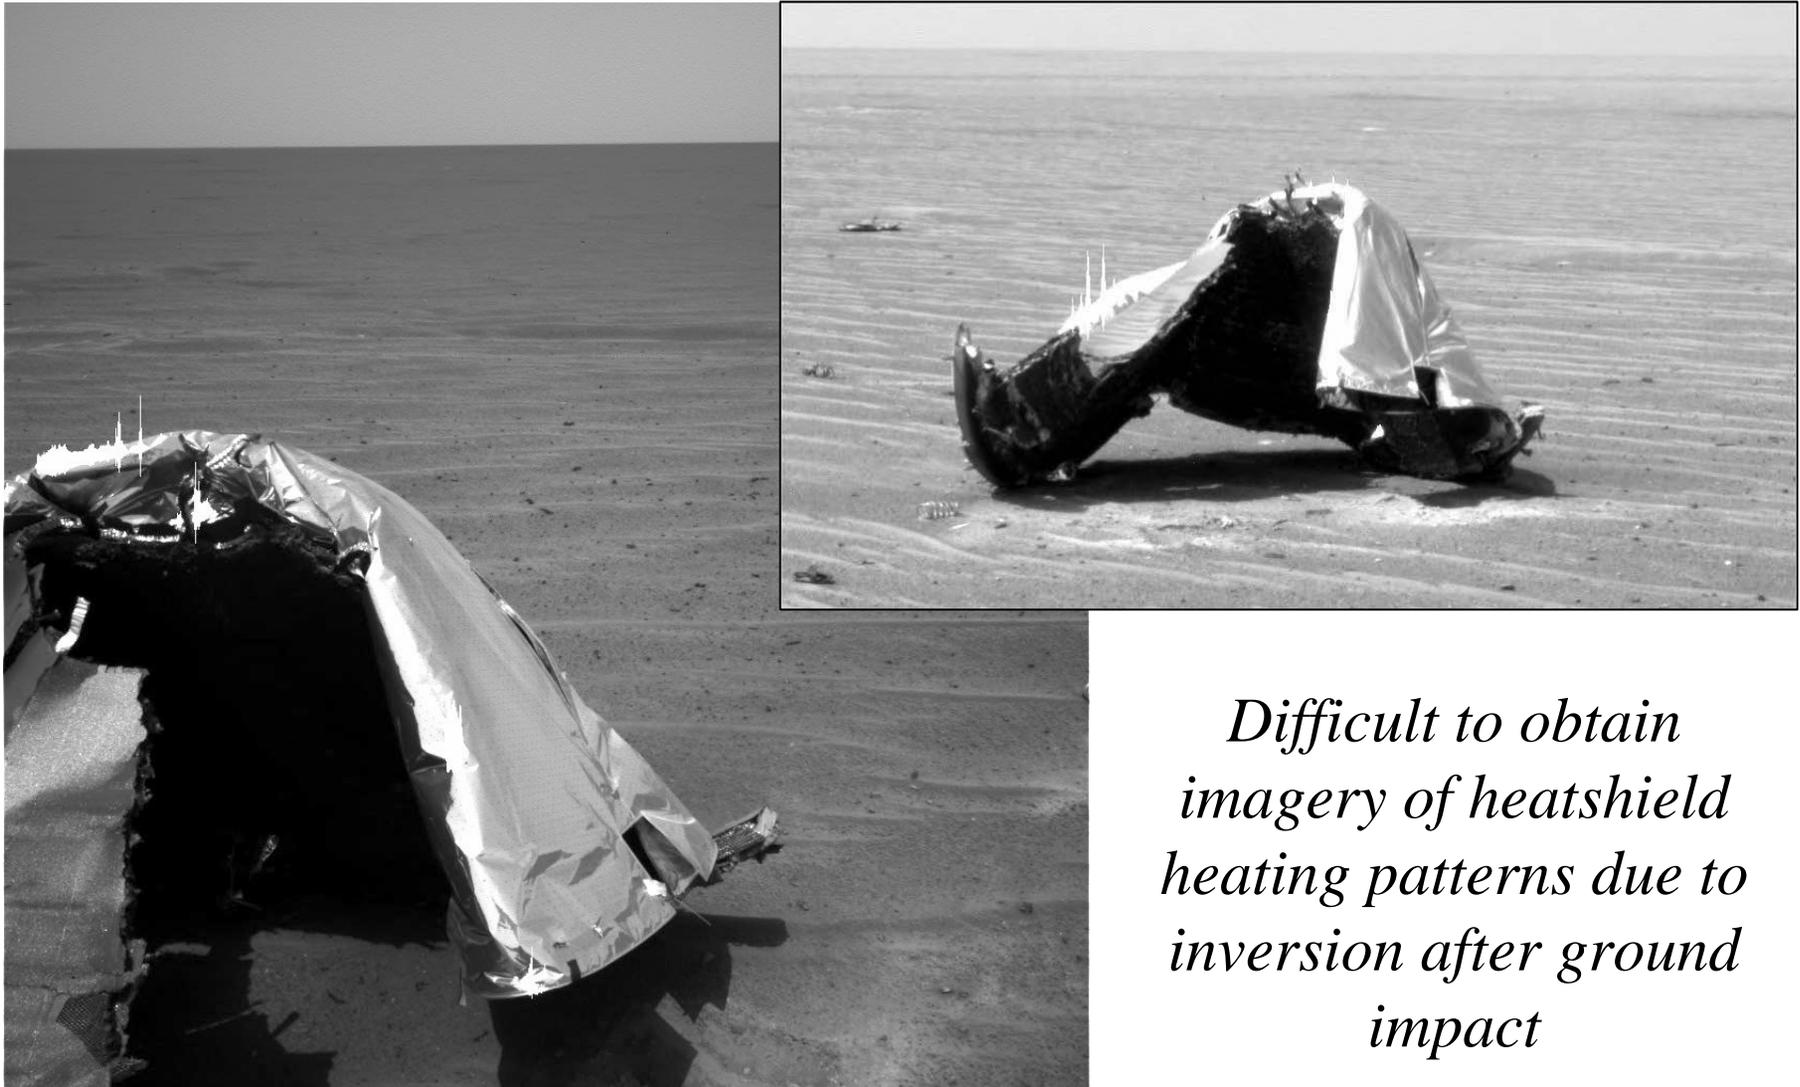
Main Heatshield Observations

*Difficult to obtain
imagery of heatshield
heating patterns due to
inversion after ground
impact*

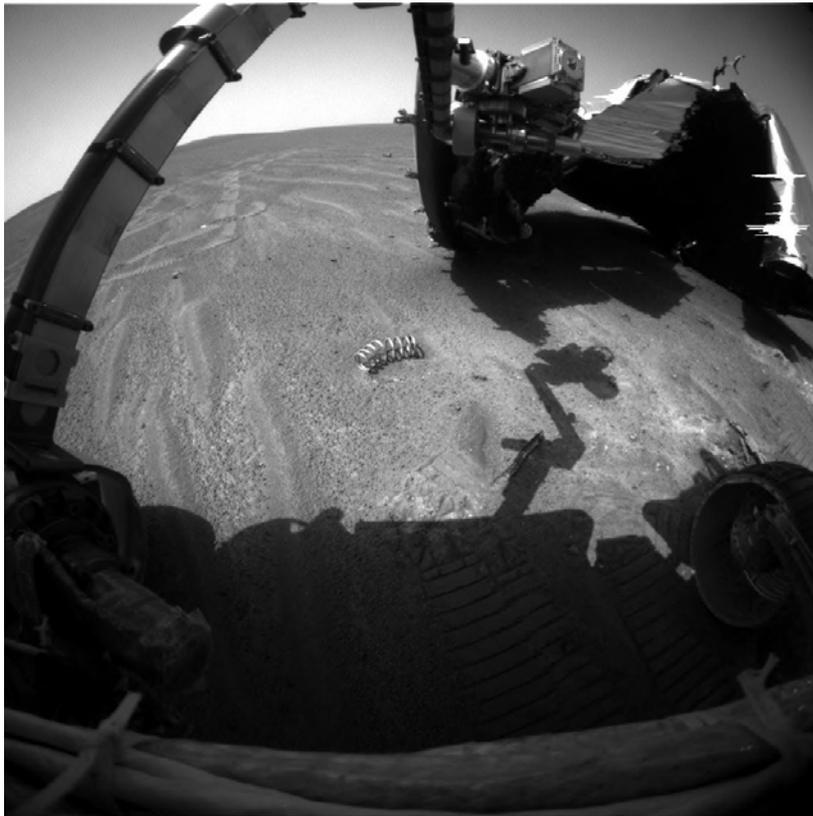
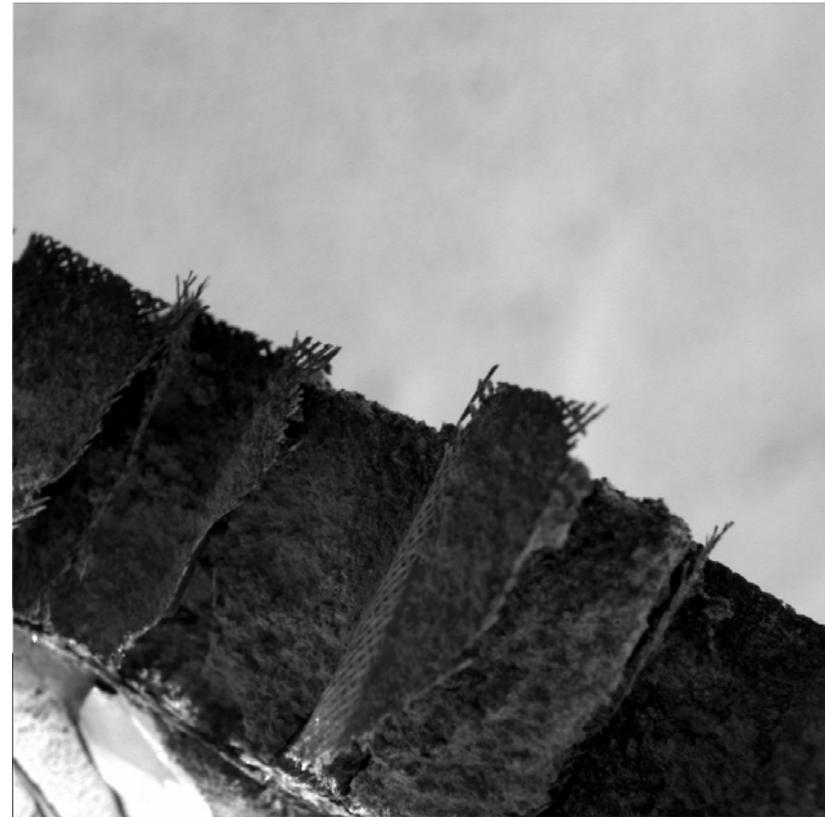
Microscopic Image Data from Heatshield

Preliminary char depth measurements show results consistent with pre-flight predictions
