GENESIS

MISHAP INVESTIGATION BOARD REPORT VOLUME I

**GENESIS MISHAP REPORT
VOLUME I**

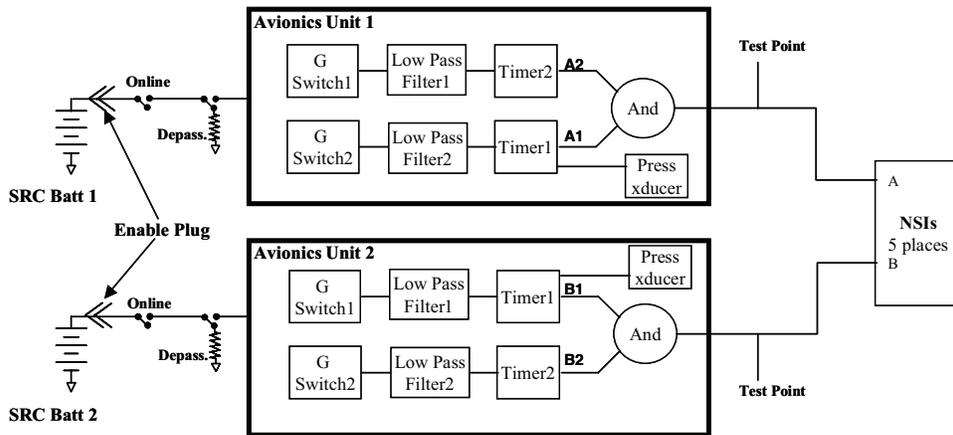
Figure 1.9. SRC pyrotechnic firing circuit layout.

The firing circuit is activated by the G-switch sensors, which are ANDed together to preclude a single switch failure from prematurely issuing a fire signal. A low-pass filter was added to prevent inadvertent G-switch sensor activation due to atmospheric transients (buffeting) during re-entry. The pressure transducer is not a backup to the G-switch sensor and is only used once the event sequence timer (EST) is running to ensure that parafoil deployment occurs at the desired altitude. A positive firing signal from the firing circuit in either AU was sufficient to fire the respective pyrotechnic device.

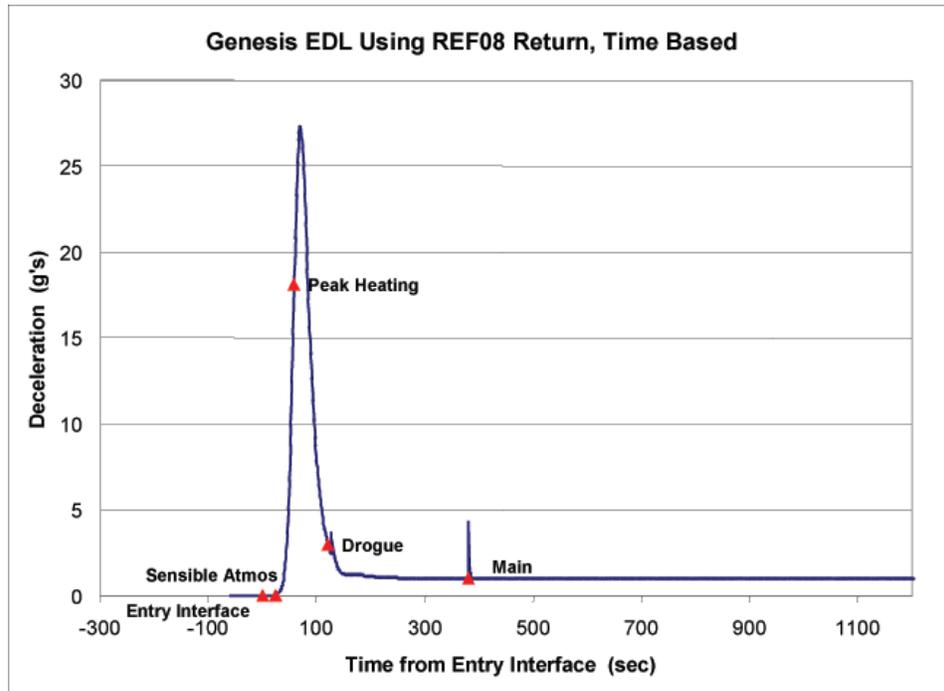
Figure 1.12.
Genesis entry g profile.

As seen in Figure 1.12, the g's build up due to the increased drag in the atmosphere. Upon reaching 3 g's, the plunger touches an electrical contact in the end of the G-switch sensor, closing the circuit and arming the sequencer. When the SRC slows down and the g's drop below 3 g's, the plunger in the G-switch sensor pushes away from the contact, which breaks the circuit and starts the sequencer.

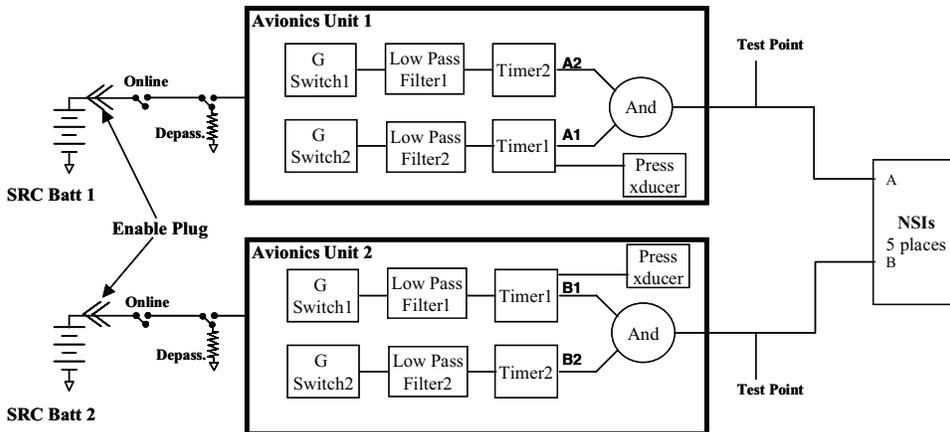
Figure B.11. SRC avionics pyrotechnic firing system.

Figure B-11 is a simplified block diagram of the SRC avionics system pyrotechnic firing system. The low-pass filter is designed to prevent inadvertent G-switch circuit atmospheric transients (buffeting) as the increasing deceleration passes through 3 g's . The G-switch sensors are 'ANDed' to preclude a single switch failure from prematurely issuing a deploy signal. The AUs are referred to in development phase documentation as 1 and 2 or A and B alternatively with 1 = A and 2 = B.

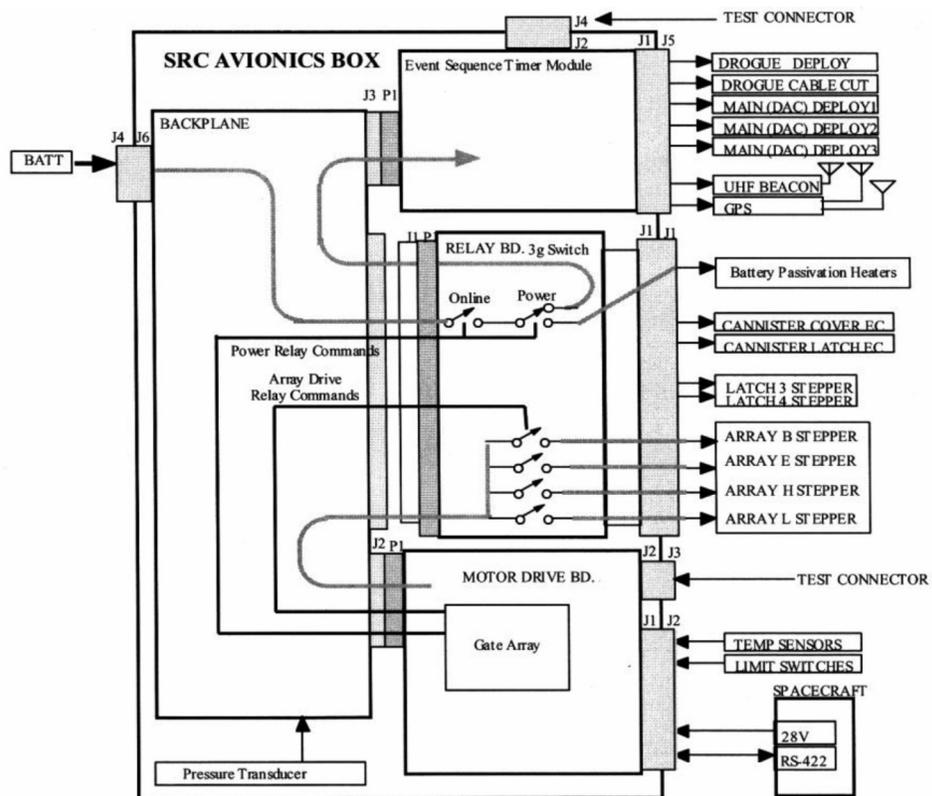
Figure B.12.
SRC avionics unit.

The AU block diagram is shown in Figure B-12. The primary functions performed by the Motor Drive Electronics (MDE) board were completed when the science canister and the SRC were closed on April 1, 2004. During the SRC Release Sequence, the relay card and the FPGA on the MDE board are used only to connect the SRC LiSO₂ batteries to the depassivation resistors attached to the interior of the heatshield first and then to the Event Sequence Timer (EST) board to power it through entry and post entry operation of the GPS transceiver and the UHF beacon. The G-switch sensors were mounted on this relay card for entry, although voltage was applied from the EST card.

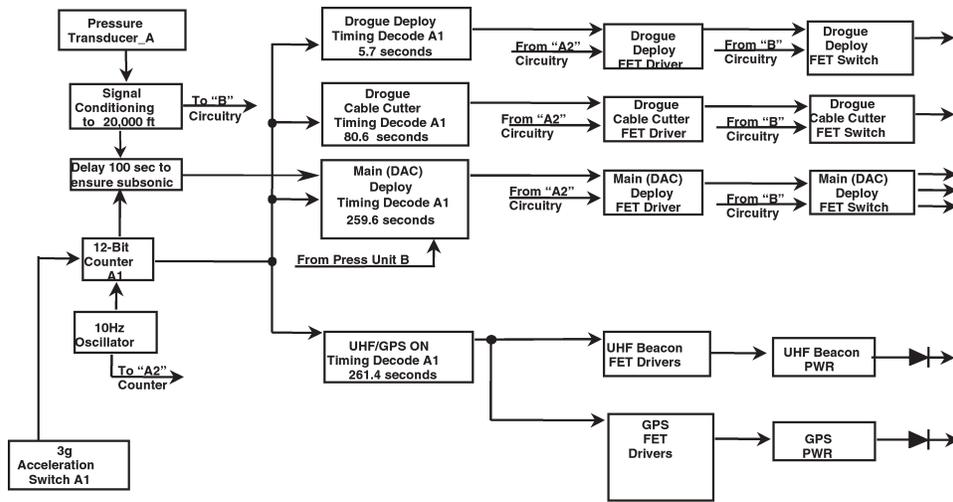
Figure B-13.
Event sequence timer.

The EST block diagram is shown in Figure B-13. The G-switch sensor initiates all the R-C timer circuits set to fit the entry profile (see Table B-3 event times). The drogue parachute stabilizes the capsule during the passage through transonic velocities, nominally being deployed at Mach 1.8. The drogue cable cut could be done anytime between drogue deploy and DACS firing. The DACS firing is timed to correspond to about 22,000 ft (72 km) above MSL. The pressure transducer is a back-up to timed parafoil deployment but is switched on by a timer sequence initiated by the G-switch sen

sor. It is intended for back-up initiation for parafoil deployment in case the estimated timing of the descent sequence was incorrect. It is not intended as a back-up to the G-switch sensor. The redundant AU circuits are cross strapped and the boxes are cross strapped, as shown in Figure B-13. The UHF beacon and the GPS transceiver provide location information in case of a failed Mid-Air Retrieval.

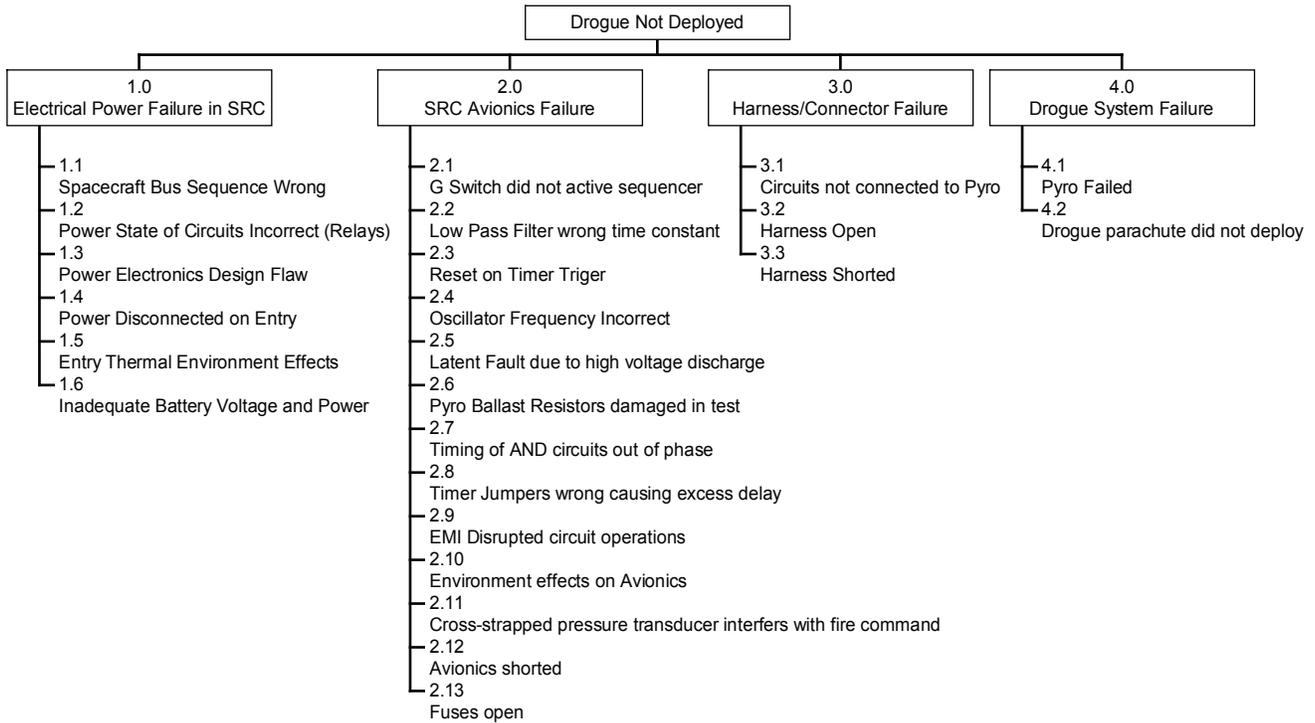
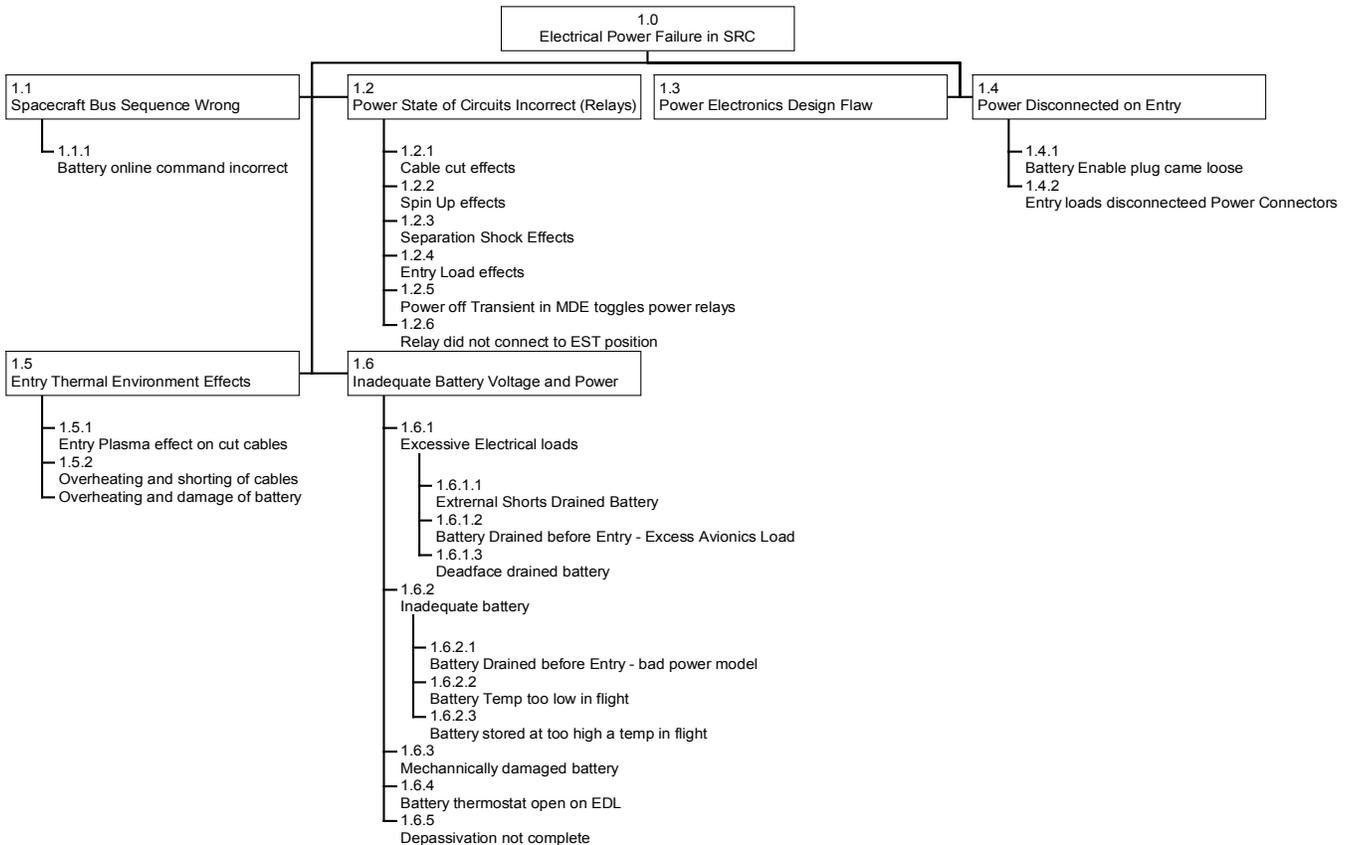
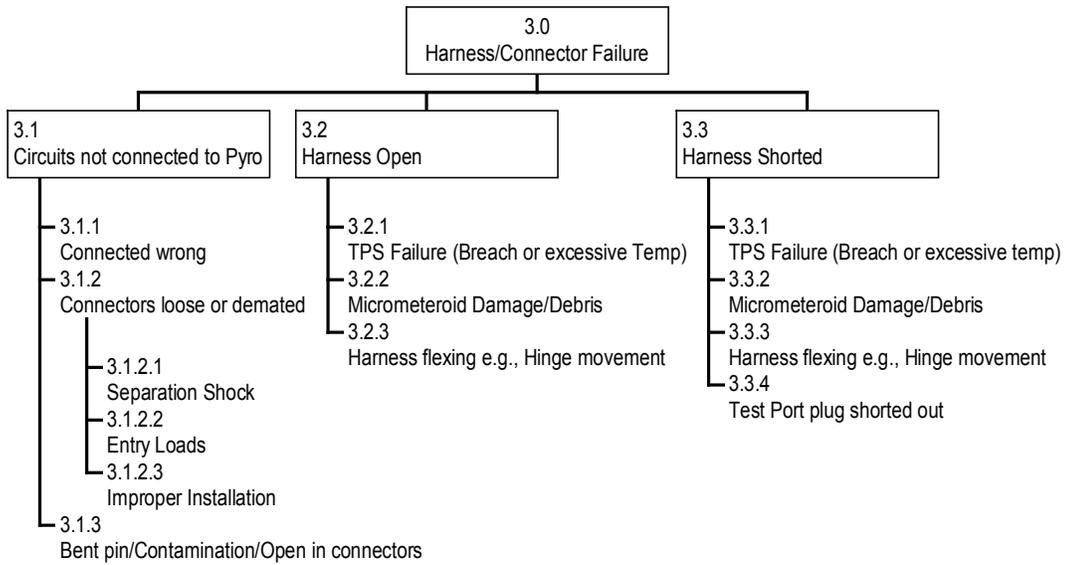
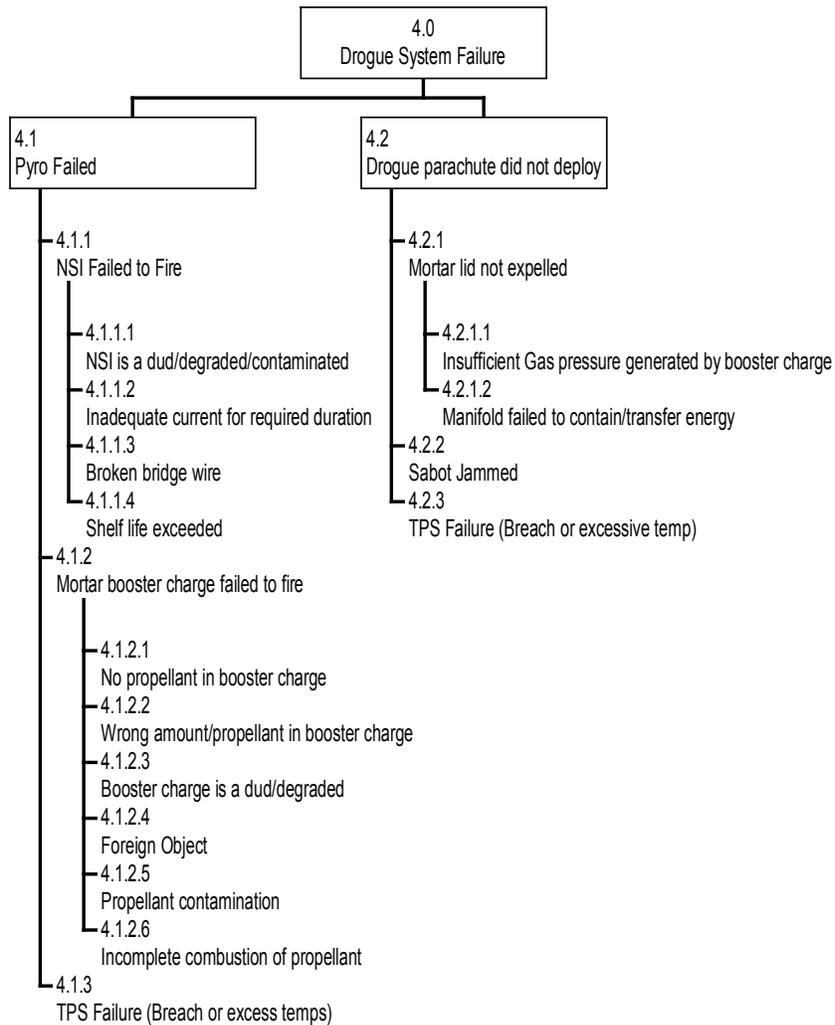
FAULT TREE DIAGRAM

Figure E-2 contains the Event and Causal Factor Tree for the Genesis mishap, a visual representation of the causes that led to the mishap. The MIB used a fault tree(see Appendix C-2.A.) to identify the possible causes leading to the mishap and the Event and Causal Factor Tree was then used to further decompose those events by asking why each event occurred. The MIB continued this “why” process until they identified the root causes and causal factors.

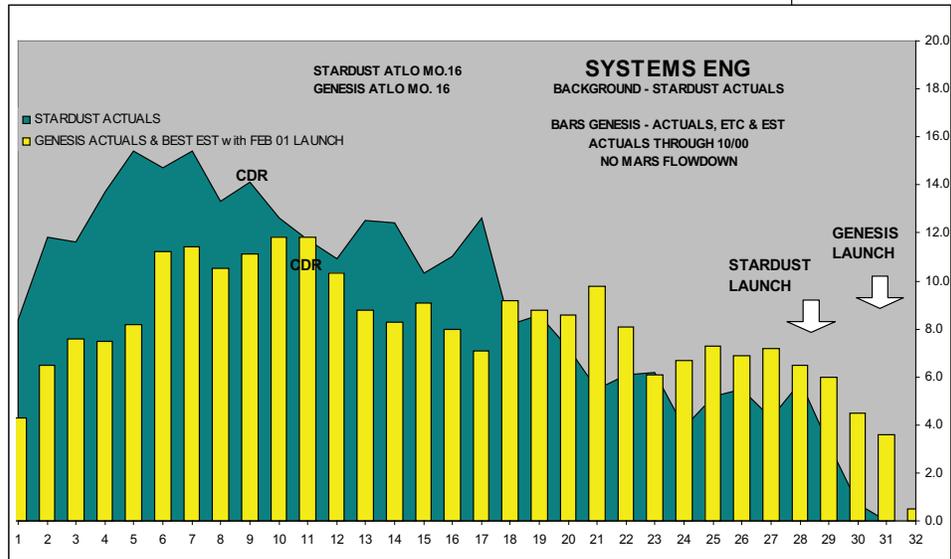
Figure E-1. Comparison of LMSS Stardust and Genesis Systems Engineering staffing profiles over project life. Genesis launch indicates planned launch; actual launch delayed late in life to accommodate Mars Odyssey needs.

The MIB drew its conclusion that the LMSS staff was inadequate by considering that the LMSS Chief Systems Engineer held three positions (Chief Systems Engineer, Systems Engineering Manager, and Contamination Engineer). It became clear from interviews that the Systems Engineering team was hard pressed to meet their stated (although incomplete) obligations, much less the additional obligations that should have been assigned.

Comparison of the LMSS Stardust and Genesis Systems Engineering Teams also indicates that the Genesis Team was too small. The small Genesis Systems Engineering staff was the result of a belief on the part of JPL and LMSS Project Management that leveraging off of Stardust heritage would allow for a smaller, less expensive team. The Board did not believe this to be a sound position, particularly given that heritage assumptions did not hold as the design matured and given that the Genesis SRC was more complex than the Stardust SRC. It was also not sound because the Systems Engineering requirements and verification processes needed to be executed with undiminished rigor.

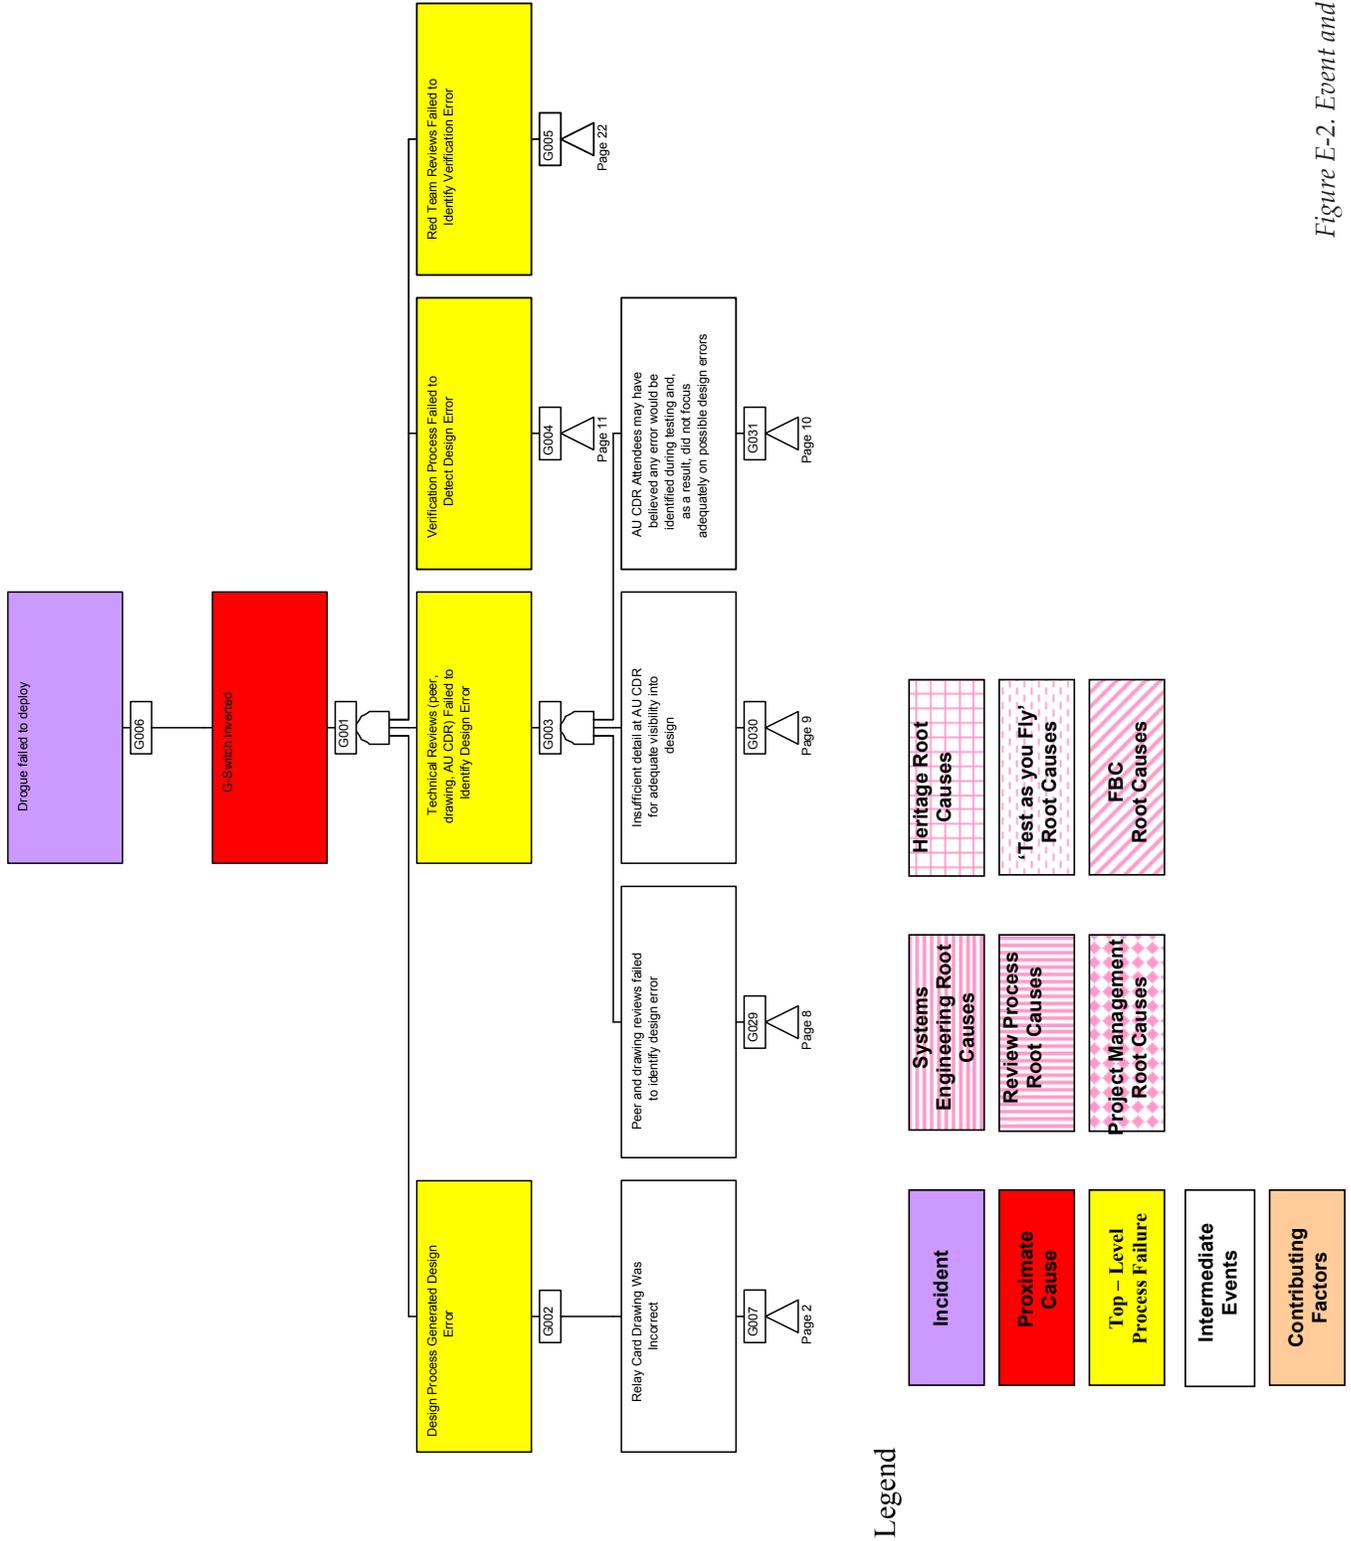
Figure E-2. Event and Causal Factor Tree.

The Genesis Project had a number of interrelated issues that led to the inversion of the G-switch sensors -- the proximate cause that resulted in the drogue parachute deployment mishap. After extensive review of the data and numerous interviews, the MIB determined that deficiencies in the following four pre-launch, top-level processes resulted in the incident, each involving multiple root causes and contributing factors:

1. the design process inverted the G-switch sensor design;
2. the design review process did not detect the design error;
3. the verification process did not detect the design error; and
4. the Red Team review process did not uncover the failure in the verification process.
